**Flood Control Project Maintenance  
Levee Inspections**

**Fall 2016 Levee Maintenance Deficiency Summary Report**

**Reclamation District No. 2101 Blewett**

**Levee Inspection Report By Mile - Fall 2016**

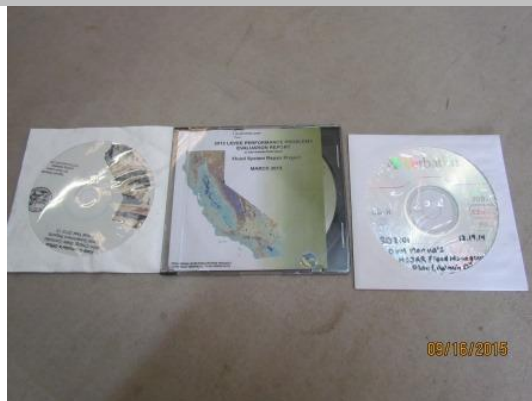
Photo 1 of 1 : FA\_2016\_RD2101\_326\_2\_20160914\_00004.jpg

LM Start		Rating **	A	Issue No.	2	
LM End		Issue Type +	Ma	Location *	N/A	
Category	Earthen Levee			GPS Latitude/Longitude		
				Start		End
Item	Operations & Maintenance Manuals				o	
					o	
DWR ID	DWR_RD2101_01_s_2013_2					
Comment Code						
Inspector Comment						
The LMA has the O&M Manual available electronically.

View of the O&amp;M manual and other documentation.

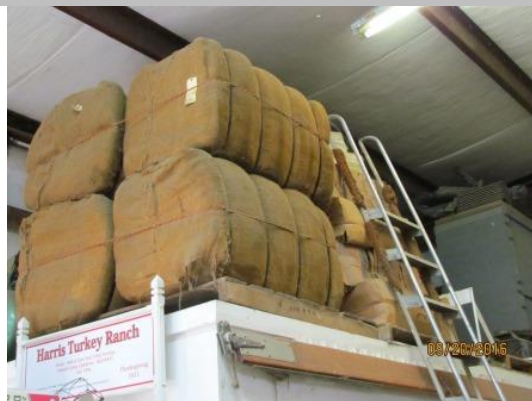
Photo 1 of 2 : FA\_2016\_RD2101\_326\_4\_20160926\_00037.jpg

LM Start		Rating **	A	Issue No.	4
LM End		Issue Type +	Ma	Location *	N/A
Category	Earthen Levee			GPS Latitude/Longitude	
				Start	End
Item	Emergency Supplies & Equipment				o
					o
DWR ID	DWR_RD2101_01_s_2013_4				
Comment Code					
Inspector Comment					
LMA has emergency supplies on site at the warehouse.

View of the emergency flood fight supplies in the shop.

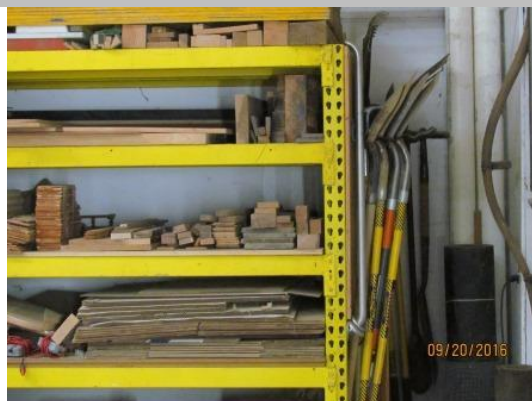
Photo 2 of 2 : FA\_2016\_RD2101\_326\_4\_20160926\_00038.jpg

Another view of the emergency flood fight supplies in the shop.

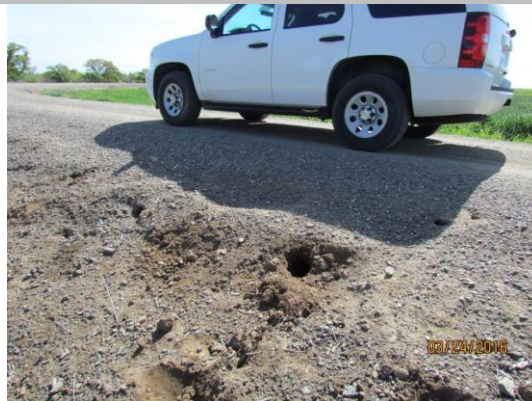
Photo 1 of 1 : FA\_2016\_RD2101\_326\_12\_20160914\_00007.jpg

LM Start	0.04	Rating **	M	Issue No.	12
LM End	0.04	Issue Type +	Ma	Location *	WS
Category	Earthen Levee			GPS Latitude/Longitude	
				Start	End
Item	Animal Control			37.657648 °	37.657648 °
				-121.253812 °	-121.253812 °
DWR ID	DWR_RD2101_01_s_2012_12				
Comment Code					
A3 : No rodents visible, but rodent burrows visible; need to backfill and compact or grout burrows.					
Inspector Comment					
LMA is actively exterminating rodents in this area.

View of the rodent holes on the waterside levee slope, facing upstream.

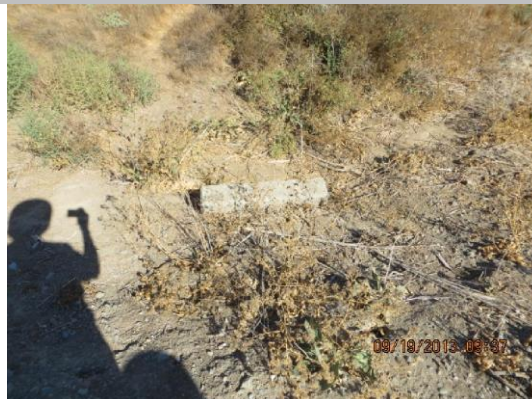
Photo 1 of 2 : UCIP\_FA\_2016\_50759\_47962.jpg

LM Start	0.05	Rating **	U	Issue No.	950
LM End	0.05	Issue Type +	En	Location *	WS
Category	Supplemental			GPS Latitude/Longitude	
				Start	End
Item	DWR UCIP Field Study			37.657801 °	37.657801 °
				-121.253745 °	-121.253745 °
DWR ID

FS\_ID:50759  
DS\_ID:20699  
EP\_NO: N/A  
Repair Type: Urgent  
Crossing Status: Found  
UCIP Comments: 11/16/2016 Dense vegetation prevents access to crossing. Recommend removing vegetation along pipe alignment and both concrete headwalls to conduct proper inspection of structure. (O. Magana - DWR UCIP)09/17/2013 Slide gate missing from WS toe.  
Pipe has heavy sediment buildup. (W. Wylie - DWR UCIP)  
FIELD\_STRUCT\_DESC: 18-inch corrugated metal drainage pipe through levee, 3 feet below crown. Concrete headwalls are located on both the waterside (WS) and landside (LS) ends. Slide gate at headwall is located on the WS end. [Additional Reference(s): DWR Levee Log, 1992. USACE San Joaquin River O&M Manual Unit No. 12, December 1968, (HLM 0.05), Drawing No. 07-04-1666, sheets 1666/18 and 1666/52, station 00+70.]  
FS Date: 11/16/2016

Headwall on WS toe.

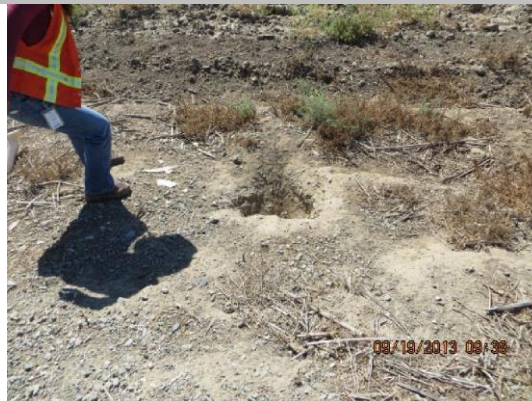
Photo 2 of 2 : UCIP\_FA\_2016\_50759\_47961.jpg

Pipe and headwall visible on LS toe.

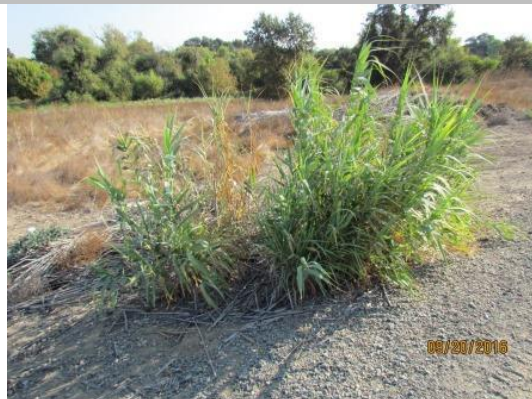
Photo 1 of 1 : FA\_2016\_RD2101\_326\_18\_20160926\_00039.jpg

LM Start	0.07	Rating **	M	Issue No.	18
LM End	0.07	Issue Type +	Ma	Location *	WS
Category	Earthen Levee			GPS Latitude/Longitude	
				Start	End
Item	Vegetation			37.657831 °	37.657831 °
				-121.253361 °	-121.253361 °
DWR ID	DWR_RD2101_01_f_2016_18				
Comment Code					
V2 : Remove the wild growth other than native grasses from the levee slopes.					
Inspector Comment					
Arundo on WS slope.

View of the arundo on the waterside levee slope.

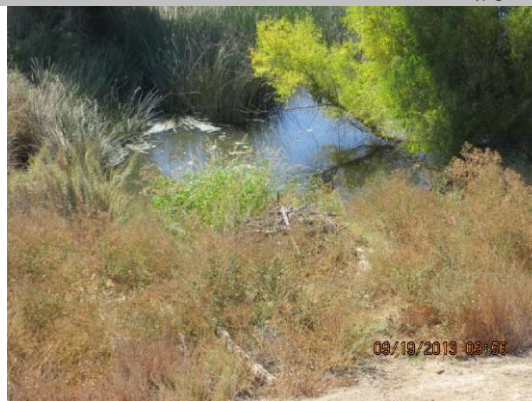
Photo 1 of 2 : UCIP\_FA\_2016\_20785\_35046.jpg

LM Start	0.31	Rating **	M	Issue No.	945
LM End	0.31	Issue Type +	En	Location *	LS
Category	Supplemental			GPS Latitude/Longitude	
				Start	End
Item	DWR UCIP Field Study			37.658142 °	37.658142 °
				-121.250047 °	-121.250047 °
DWR ID					
Comment Code					
Inspector Comment					
FS_ID:20785					
DS_ID:20701					
EP_NO: N/A					
Repair Type: Non-Urgent					
Crossing Status: Found					
UCIP Comments: Inlet blocked by soil from beaver activity. Outlet covered in soil.					
FIELD_STRUCT_DESC: 24-inch corrugated metal pipe through levee 21.0 feet below crown. Headwall and slide gate on the landward end. Concrete "U" headwall and flap gate on the waterward end. Originally included in the 1968 O&M manual.					
FS Date: 9/19/2013

Slide gate at concrete headwall on LS toe.

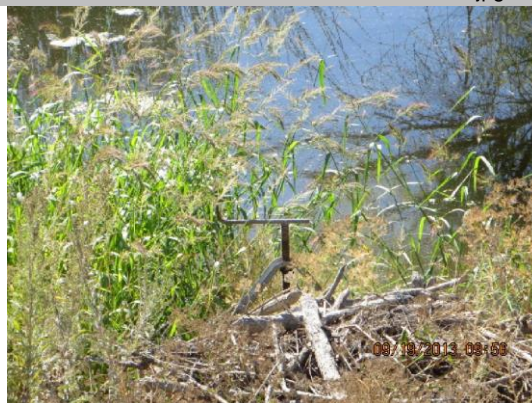
Photo 2 of 2 : UCIP\_FA\_2016\_20785\_35045.jpg

Slide gate at concrete headwall on LS toe.

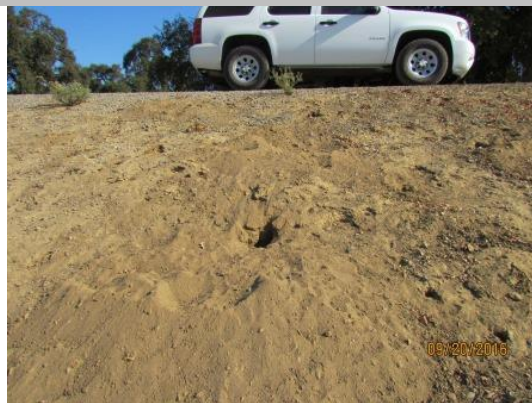
Photo 1 of 1 : FA\_2016\_RD2101\_326\_21\_20160926\_00041.jpg

LM Start	0.86	Rating **	M	Issue No.	21
LM End	0.86	Issue Type +	Ma	Location *	LS
Category	Earthen Levee			GPS Latitude/Longitude	
				Start	End
Item	Animal Control			37.658715 °	37.658715 °
				-121.241945 °	-121.241945 °
DWR ID	DWR_RD2101_01_f_2016_21				
Comment Code					
A1 : Exterminate rodents and backfill and compact or grout burrows.					
Inspector Comment

View of the rodent hole on the landside slope.

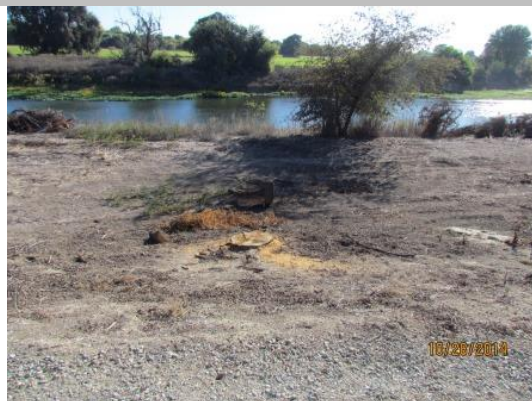
Photo 1 of 1 : FA\_2016\_RD2101\_326\_33\_20160914\_00015.jpg

LM Start	1.02	Rating **	N	Issue No.	33
LM End	1.02	Issue Type +	Ma	Location *	WS
Category	Earthen Levee			GPS Latitude/Longitude	
				Start	End
Item	Trim / Thin Trees			37.656745 °	37.656745 °
				-121.241104 °	-121.241104 °
DWR ID	DWR_RD2101_01_f_2014_33				
Comment Code					
T5 : Tree stumps.					
Inspector Comment

View of the tree stump at the waterside levee toe.

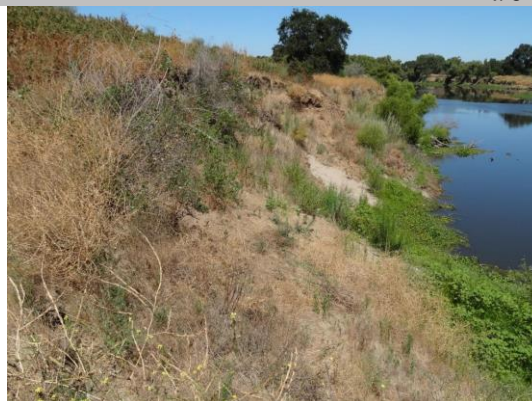
Photo 1 of 3 : SJR2016\_RD2101U01RM73.92\_1.jpg

LM Start	1.86	Rating **	U	Issue No.	1
LM End	1.95	Issue Type +	Ma	Location *	WS
Category	Supplemental			GPS Latitude/Longitude	
				Start	End
Item	DWR Erosion Survey			37.650259 °	37.650259 °
				-121.228961 °	-121.228961 °
DWR ID

07/12/2016: No significant change observed.  
 08/19/2015: No significant change observed.  
 07/17/2014: No significant change observed.  
 09/20/2013: Site has been visited. There are signs of further erosion development along the levee slope and toe.  
 07/18/2012: The erosion has further developed toward levee crown. Vegetation has been removed.  
 08/18/2011: The erosion progressed significantly during the past flood season. The levee toe along the erosion site was washed away, and the erosion has cut the levee structure up to the point about 1/3 of the levee slope. The scarp height is approximately 17 feet. Very dense vegetation and trees are visible.  
 10/19/2010: No significant change observed on site. Remaining levee berm topsoil is of silty sand mixture. The erosion is near the downstream transition. An eddy has formed, and has scoured away a 100-foot section of the bank, possibly encroaching into the levee prism. Vegetation on site includes willows, oak, and cotton wood located from the bench to the toe. On the landside are rows of corn crop.

08/05/2010: Recommended for Repair, per CLRO.  
 2009: Site recommended as annual assessment and monitoring if critical erosion site, per CLRO CES Evaluation 2008 Report; an eddy has formed, eroding bank and intruding into the levee prism; Site # is the same as RM76.3, LM1.89; previously rated "U".  
 08/30/2007: Recommended for short list of immediate repair sites; silty sand levee material. [2016 Site ID:RD2101U01RM73.92]

Upstream view of the erosion.

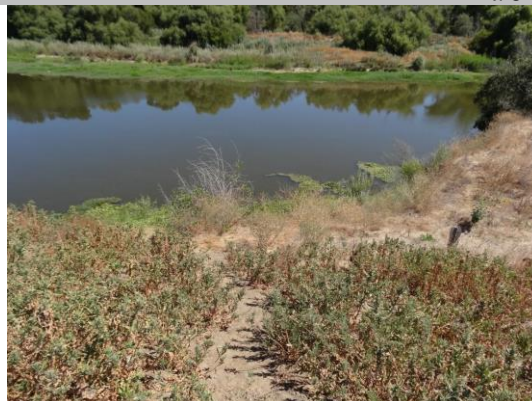
Photo 2 of 3 : SJR2016\_RD2101U01RM73.92\_2.jpg

Looking at the erosion from the levee top.

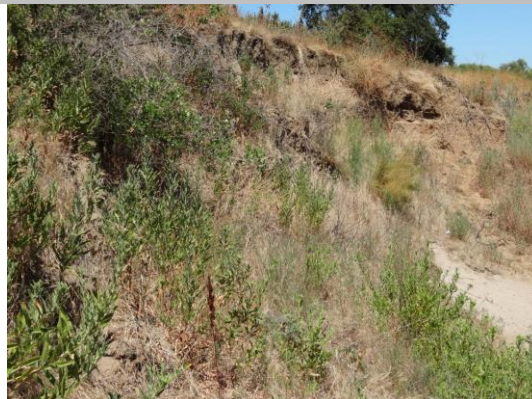
Photo 3 of 3 : SJR2016\_RD2101U01RM73.92\_4.jpg

Close view of the erosion. Levee crest is approximately 8 feet above the erosion.

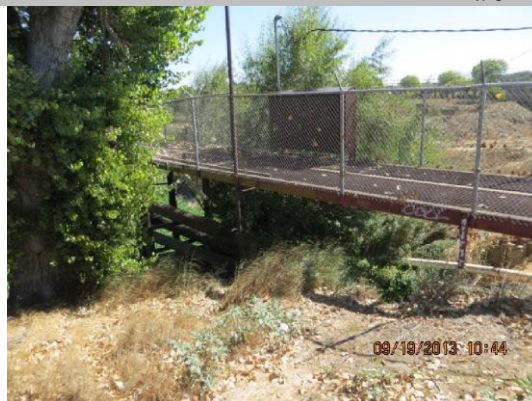
Photo 1 of 2 : UCIP\_FA\_2016\_20865\_35110.jpg

LM Start	2.71	Rating **	M	Issue No.	946
LM End	2.71	Issue Type +	En	Location *	CR
Category	Supplemental			GPS Latitude/Longitude	
				Start	End
Item	DWR UCIP Field Study			37.641976 °	37.641976 °
				-121.229745 °	-121.229745 °
DWR ID					
Comment Code					
Inspector Comment					
FS_ID:20865 DS_ID:20711 EP_NO: N/A Repair Type: Non-Urgent Crossing Status: Found UCIP Comments: Pipe leaking at pipe/concrete connection on WS slope. FIELD_STRUCT_DESC: 2 of 3: 20-inch steel pipe through levee 10.0-feet below crown encased in concrete. Pump on steel pier on WS. Gate valve in 16'X7' concrete vault on WS shoulder. Pipes discharge into concrete canal on LS toe. Originally included in the 1968 O&M manual. FS Date: 9/19/2013

Pump on metal pier on WS.

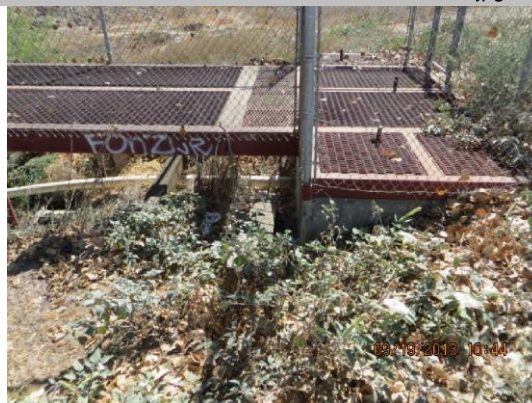
Photo 2 of 2 : UCIP\_FA\_2016\_20865\_35109.jpg

Gate valve in concrete vault on WS shoulder.

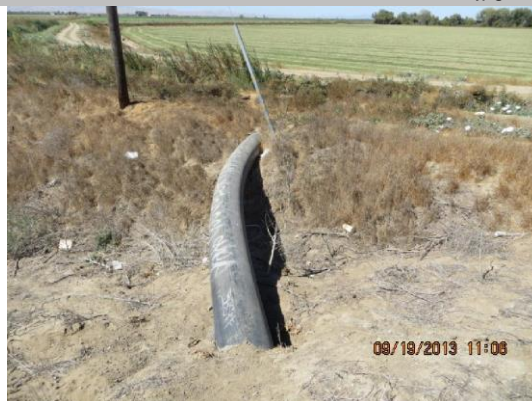
Photo 1 of 2 : UCIP\_FA\_2016\_22915\_39043.jpg

LM Start	2.72	Rating **	M	Issue No.	949
LM End	2.72	Issue Type +	En	Location *	CR
Category	Supplemental			GPS Latitude/Longitude	
				Start	End
Item	DWR UCIP Field Study			37.641798 °	37.641798 °
				-121.229714 °	-121.229714 °
DWR ID					
Comment Code					
Inspector Comment					
FS_ID:22915					
DS_ID:24679					
EP_NO: N/A					
Repair Type: Non-Urgent					
Crossing Status: Found					
UCIP Comments: 09/26/2016 - (T. Hatch/UCIP) Inspector indicated that pipe had been removed for several years. Need additional information to determine if the pipe was removed properly and the levee recompacted to specifications.					
09/19/2013 - (W. Wylie/UCIP) No permit identified for this crossing.					
FIELD_STRUCT_DESC: *REMOVED* 18-inch PVC irrigation pipe through the levee 3.5-feet below the crown. No pump or other appurtenances visible.					
FS Date: 9/19/2013

18-inch PVC pipe visible at LS slope.

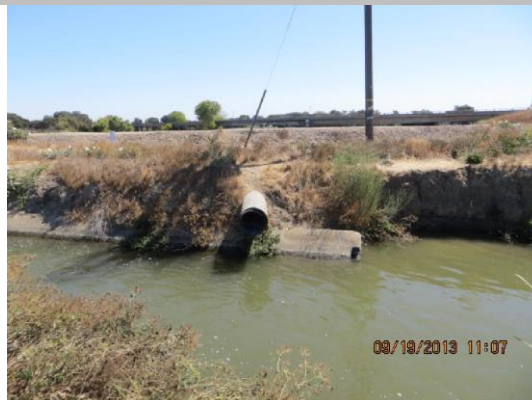
Photo 2 of 2 : UCIP\_FA\_2016\_22915\_39042.jpg

18-inch PVC pipe visible at outlet to irrigation canal on LS slope.

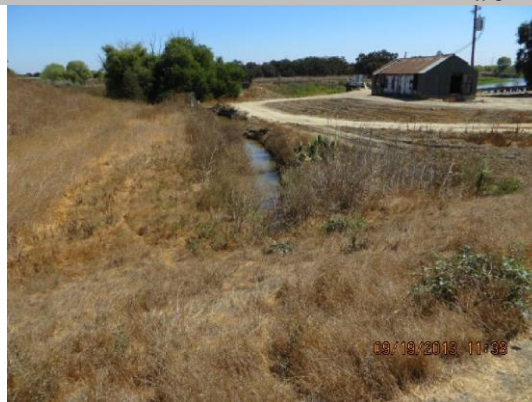
Photo 2 of 2 : UCIP\_FA\_2016\_50760\_35141.jpg

Concrete headwall visible on WS toe at canal.

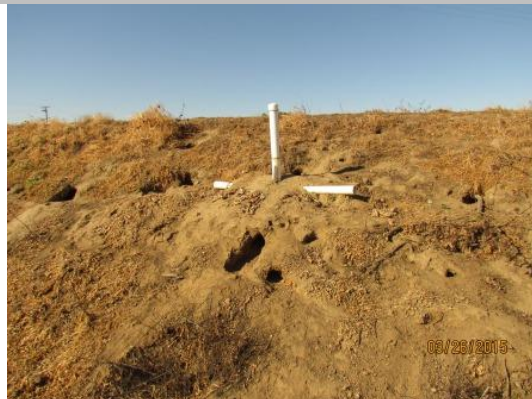
Photo 1 of 1 : FA\_2016\_RD2101\_326\_27\_20160914\_00011.jpg

LM Start	2.83	Rating **	U	Issue No.	27
LM End	2.83	Issue Type +	Ma	Location *	WS
Category	Earthen Levee			GPS Latitude/Longitude	
				Start	End
Item	Animal Control			37.640425 °	37.640425 °
				-121.230139 °	-121.230139 °
DWR ID	DWR_RD2101_01_s_2012_27				
Comment Code					
A3 : No rodents visible, but rodent burrows visible; need to backfill and compact or grout burrows.					
Inspector Comment					
Burrows on both sides of levee. Backfill the burrows to restore the levee to original condition.

View of multiple rodent holes on the levee slope.

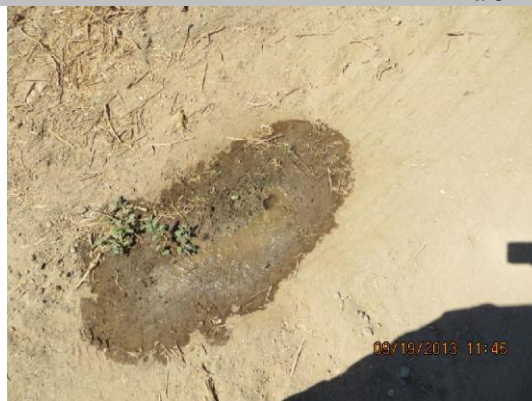
Photo 1 of 2 : UCIP\_FA\_2016\_20873\_35146.jpg

LM Start	2.85	Rating **	M	Issue No.	947
LM End	2.85	Issue Type +	En	Location *	WS
Category	Supplemental			GPS Latitude/Longitude	
				Start	End
Item	DWR UCIP Field Study			37.640185 °	37.640185 °
				-121.230067 °	-121.230067 °
DWR ID					
Comment Code					
Inspector Comment					
FS_ID:20873 DS_ID:20706 EP_NO: N/A Repair Type: Non-Urgent Crossing Status: Found UCIP Comments: Leaks off LS toe may indicate internal failure. Good candidate for video inspection. FIELD_STRUCT_DESC: 1 of 2: 24-inch concrete irrigation pipe through levee 11.0 feet below crown. Pump on metal pier at WS berm. Screw gates in 6'X10.5' concrete box on waterward side. 12-inch steel riser next to concrete box with slide gates. Abandoned pump house on waterward side. Originally included in the 1968 O&M manual. FS Date: 9/19/2013

Leak in pipe off LS toe.

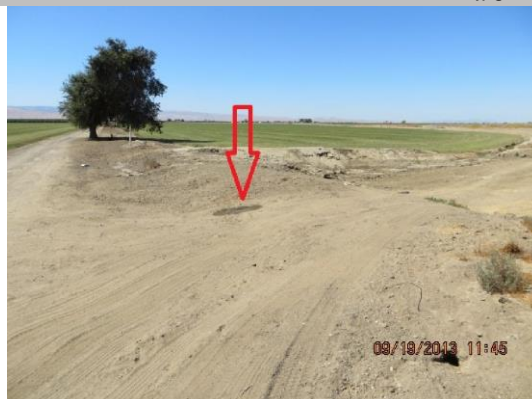
Photo 2 of 2 : UCIP\_FA\_2016\_20873\_35145.jpg

Leak in pipe off LS toe.

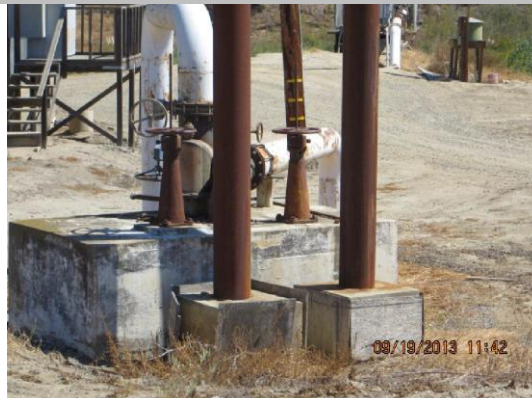
Photo 1 of 2 : UCIP\_FA\_2016\_20874\_35151.jpg

LM Start	2.85	Rating **	M	Issue No.	948
LM End	2.85	Issue Type +	En	Location *	WS
Category	Supplemental			GPS Latitude/Longitude	
				Start	End
Item	DWR UCIP Field Study			37.640185 °	37.640185 °
				-121.230067 °	-121.230067 °
DWR ID					
Comment Code					
Inspector Comment					
FS_ID:20874 DS_ID:20712 EP_NO: N/A Repair Type: Non-Urgent Crossing Status: Found UCIP Comments: Leak off LS toe may indicate internal failure. Good candidate for video inspection. FIELD_STRUCT_DESC: 2 of 2: 30-inch concrete pipe through levee 11.0 feet below crown. Pump on metal pier on waterside berm. 12-inch steel riser next to 6'X10.5' concrete box with Screw gate inside on waterward side. Abandoned Pump house on waterward side. Originally included in the 1968 O&M manual. FS Date: 9/19/2013

Gatevalve in concrete vault with standpipe off WS toe.

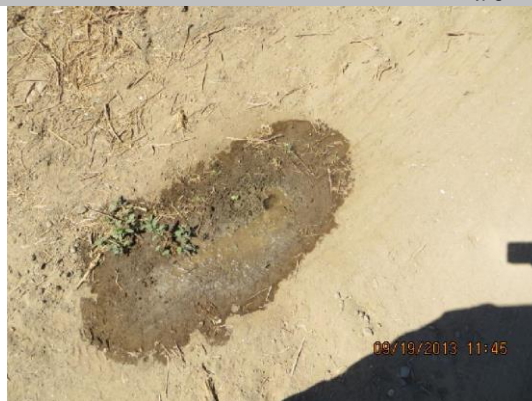
Photo 2 of 2 : UCIP\_FA\_2016\_20874\_35150.jpg

Leak in pipe off LS toe.

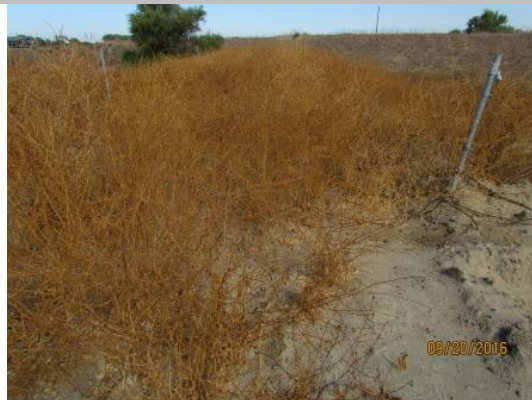
Photo 1 of 1 : FA\_2016\_RD2101\_326\_34\_20160926\_00043.jpg

LM Start	2.85	Rating **	A/W	Issue No.	34
LM End	2.85	Issue Type +	Ma	Location *	CR
Category	Earthen Levee			GPS Latitude/Longitude	
				Start	End
Item	Vegetation			37.640148 °	37.640148 °
				-121.230031 °	-121.230031 °
DWR ID	DWR_RD2101_01_f_2016_34				
Comment Code					
V1 : Control annual grass and weeds on the levee slopes and easements.					
Inspector Comment					
LMA dragged the levee to remove unwanted vegetation.

View of the vegetation on levee crown.

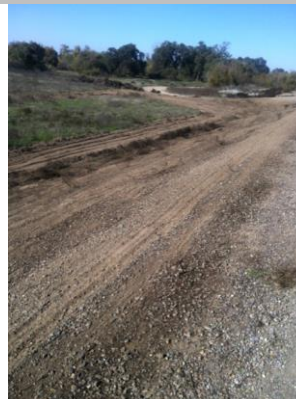
Photo 1 of 1 : FA\_2016\_RD2101\_327\_1\_20161117\_00002.jpg

LM Start	0.03	Rating **	A	Issue No.	1
LM End	0.29	Issue Type +	Ma	Location *	WS
Category	Earthen Levee			GPS Latitude/Longitude	
				Start	End
Item	Vegetation			37.660165 °	37.663866 °
				-121.243415 °	-121.242879 °
DWR ID	DWR_RD2101_02_f_2016_1				
Comment Code					
V1 : Control annual grass and weeds on the levee slopes and easements.					
Inspector Comment					
LMA removed unwanted vegetation from levee slope.

View of the maintained waterside levee slope.
